# Powderhall Footbridge No. 2 Briefing Note

City & Neighbourhood Services and Transport & Mobility

14/10/2026

| <b>Subject:</b> | Failure of nodes in main span top chord | | |

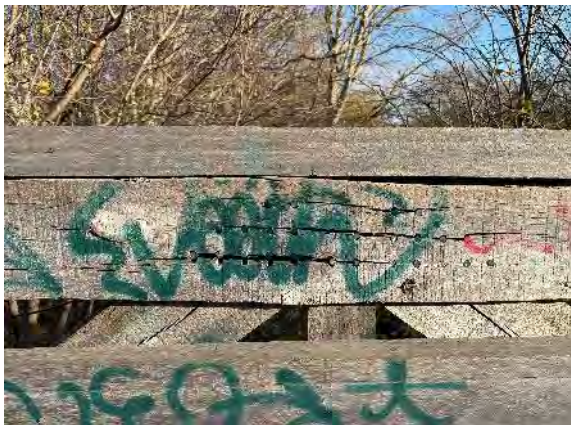
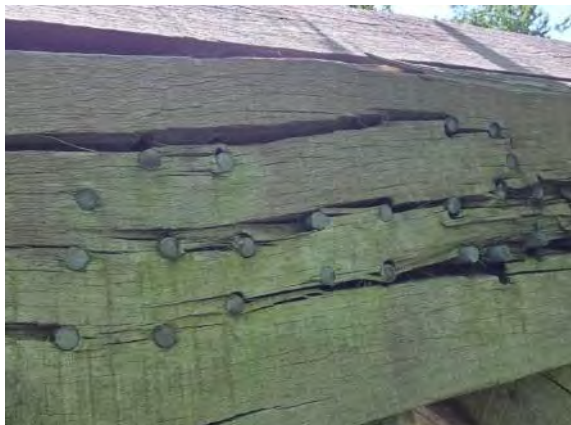
| Example of a defective joint (internal view) | Example of a defective joint (external view) |

- 5.1 The footbridge was recommended for closure following an independent review of cracks in the joints of the top chord, by Mott MacDonald in June 2026. This recommendation was implemented by the City of Edinburgh Council (CEC) immediately.

- Significant splitting was identified at several joints in the top chord of the longest span of the footbridge which are critical to the stability of the footbridge.

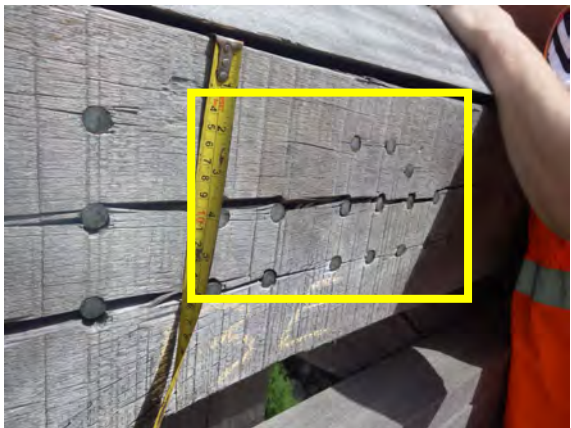
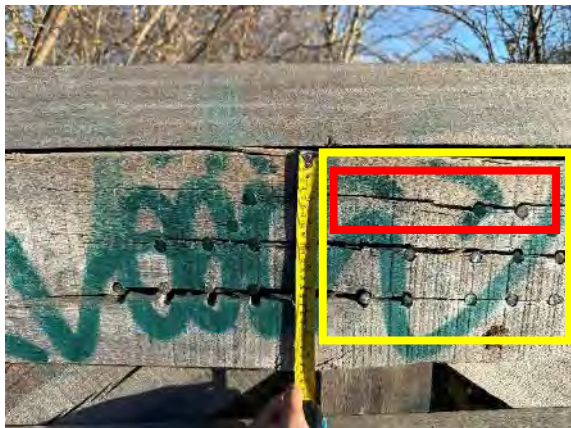
| Crack of greatest concern – east elevation (2017) | Crack of greatest concern – east elevation (2025) |

The area outlined in yellow above is provided as a common reference point between the two photographs. The area outlined in red above indicates a new crack that has developed since the 2017 inspection.

During the 2017 inspection, the maximum crack width measured at this joint was 6mm, whereas from the 2025 inspection, the maximum crack width measured was 15mm.

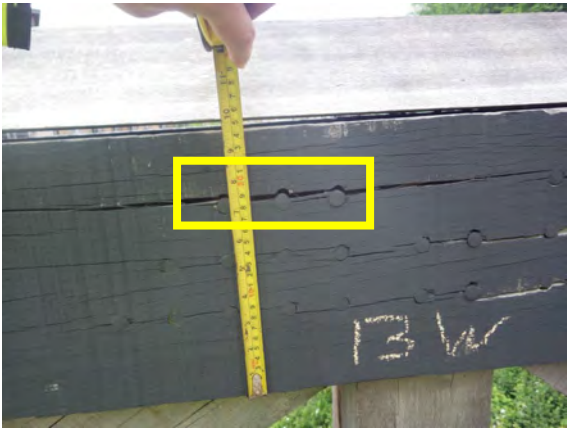
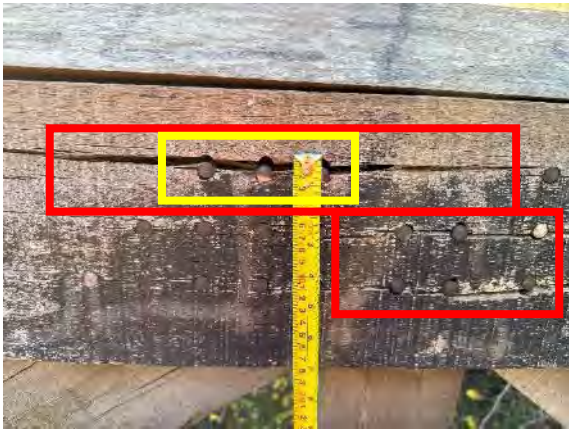
| West elevation crack (2017) | West elevation crack (2025) |

The area outlined in yellow above is provided as a common reference point between the two photographs. The areas outlined in red shows evidence of the cracks opening when compared to the earlier photograph.

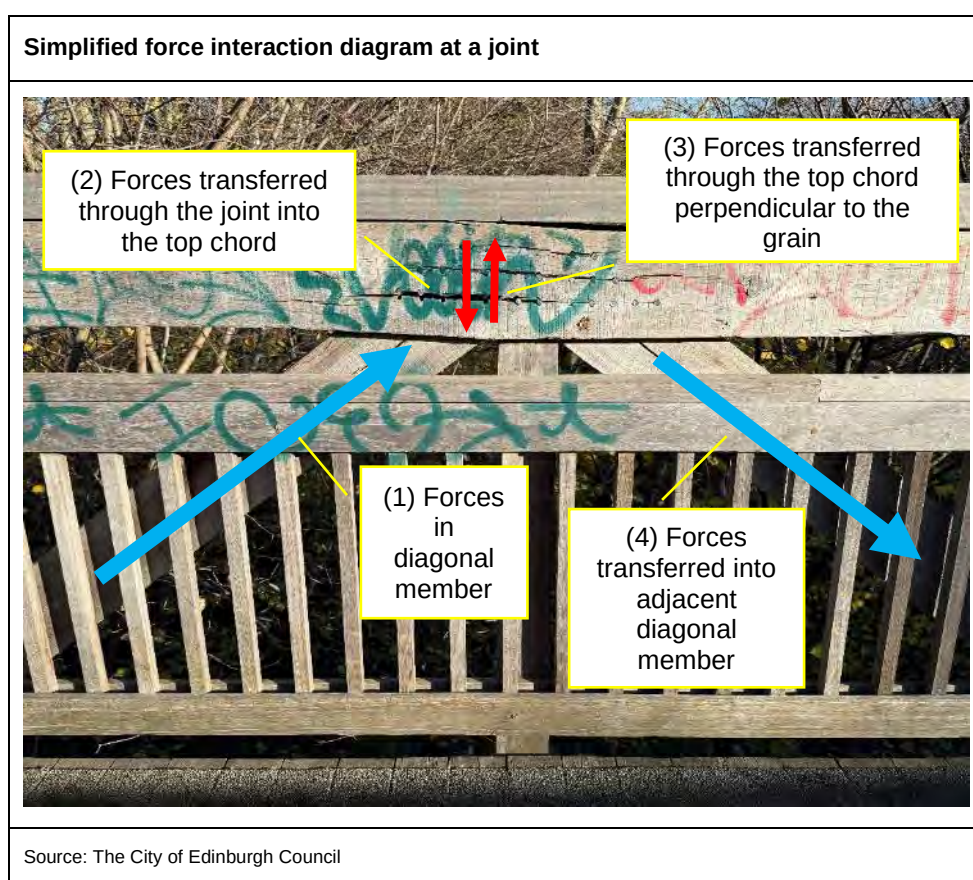
- The joint detail allows water to collect and enter the timber, where it becomes trapped. This can cause the timber to swell and deteriorate, leading to further cracking and opening of the joint. This allows more water to enter, causing a cycle of water ingress and deterioration.
- 6.3 This method of construction was designed in accordance with the standards and engineering knowledge applicable at the time.
- 6.4 Examples of similar timber hardwood truss footbridges, constructed using mortice and tenon joints with dowels, which have failed in recent years are shown below:

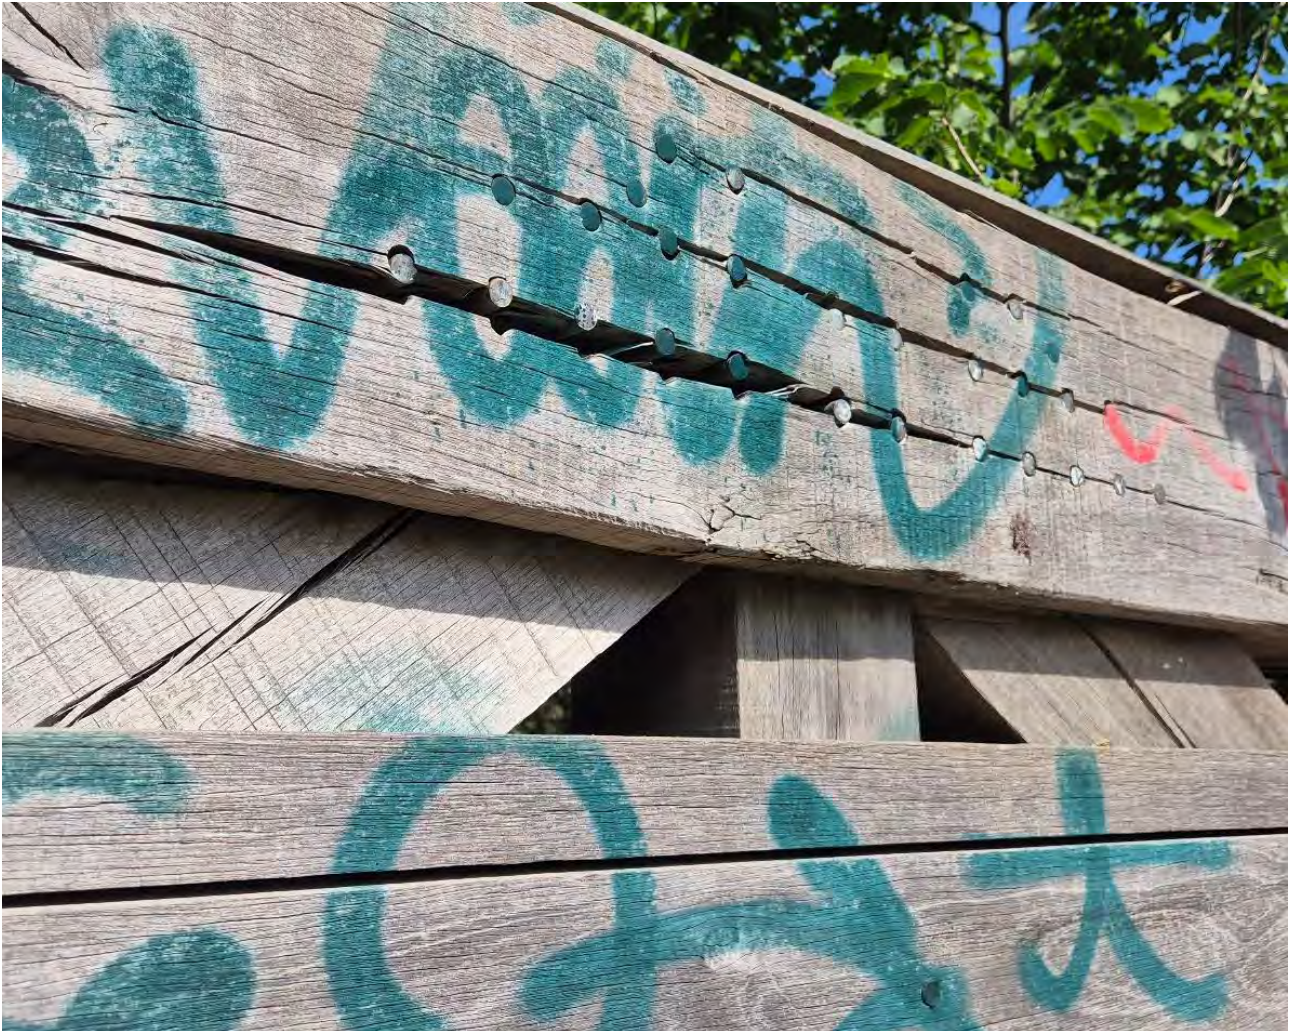
1. The nodes in the top chord (mortise and tenon joints with steel dowels) which are readily inspectable from the footpath exhibit signs of splitting along the grain of the timber in the top chord.

2. The main span is approximately twice the length of the two side spans. The nodes towards the end of this span, which must transmit the highest forces between diagonal members, are detailed with the same dowel arrangement as the other nodes and exhibit the most serious splitting.

3. The severity of the splitting at the most highly stressed locations indicates that the connection has failed to perform as the designer intended.
4. Failure of the node may be possible at any time, either due to an incidence of high live loading, environmental actions such as unusually hot weather, or under dead load after further deterioration. None of these risks are currently controlled.

**Figure 1: Top chord node – severe splitting in all members. Note right-hand diagonal displacing up and left-hand diagonal pulling down**

## **To ensure public safety, we recommend a closure of the footbridge to the public is implemented urgently.**

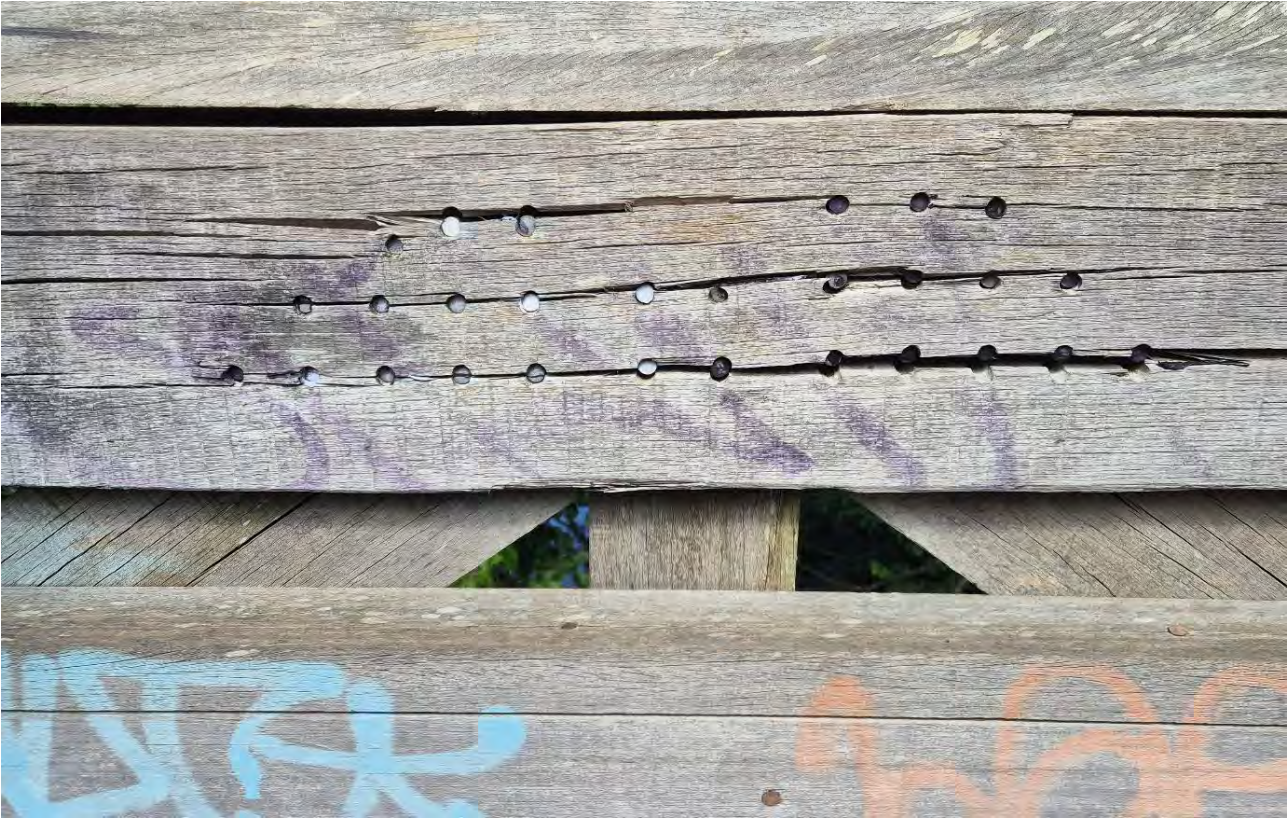
Figure 2: Top chord node – internal view.

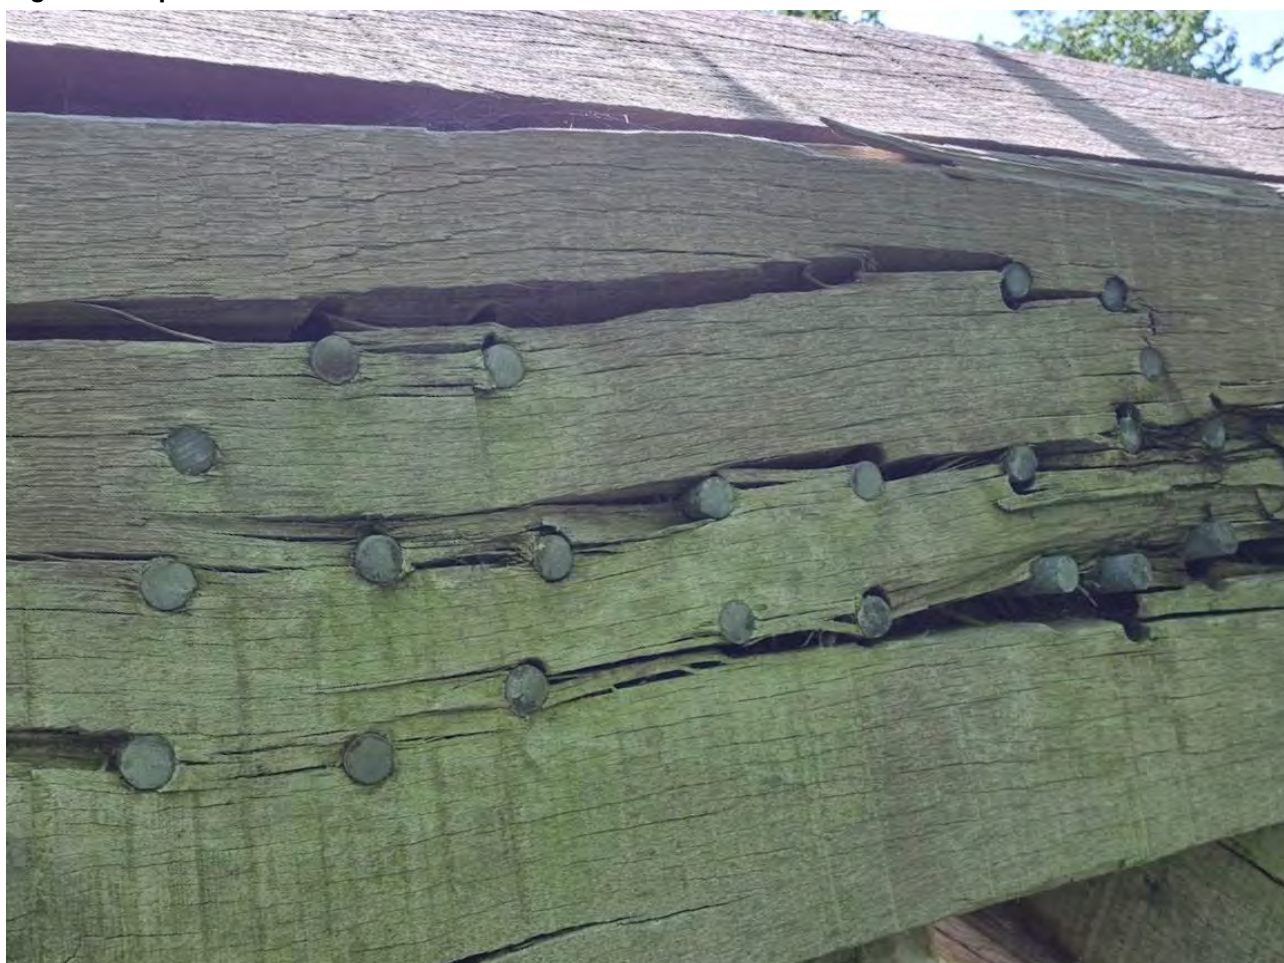
**Figure 3: Top chord node – external view**
