# Powderhall Footbridge No. 2 Briefing Note

City & Neighbourhood Services and Transport & Mobility

14/10/2026

| <b>Subject:</b> | Failure of nodes in main span top chord | | |

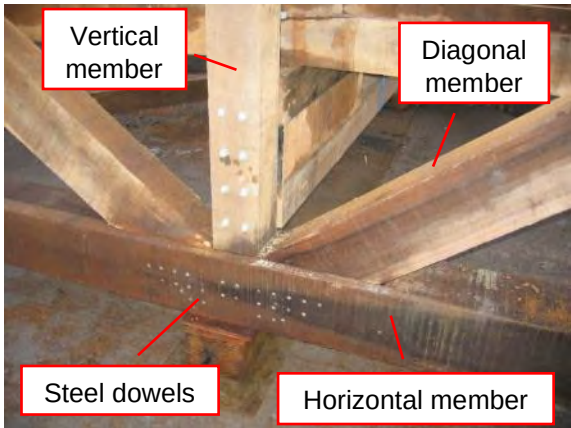
| Central span being lifted into position from the former Powderhall Waste Transfer Station site (2008) | One of the mortice and tenon joints with steel dowels (2008) |
| | <p>Diagonal and vertical members slot into the horizontal member and is secured with steel dowels.</p> |
